NASA/TM-2003-212439  
ARL-TR-3046

# Characterization of Cracking and Crack Growth Properties of the C5A Aircraft Tie-Box Forging

*Robert S. Piascik and Stephen W. Smith  
Langley Research Center, Hampton, Virginia*

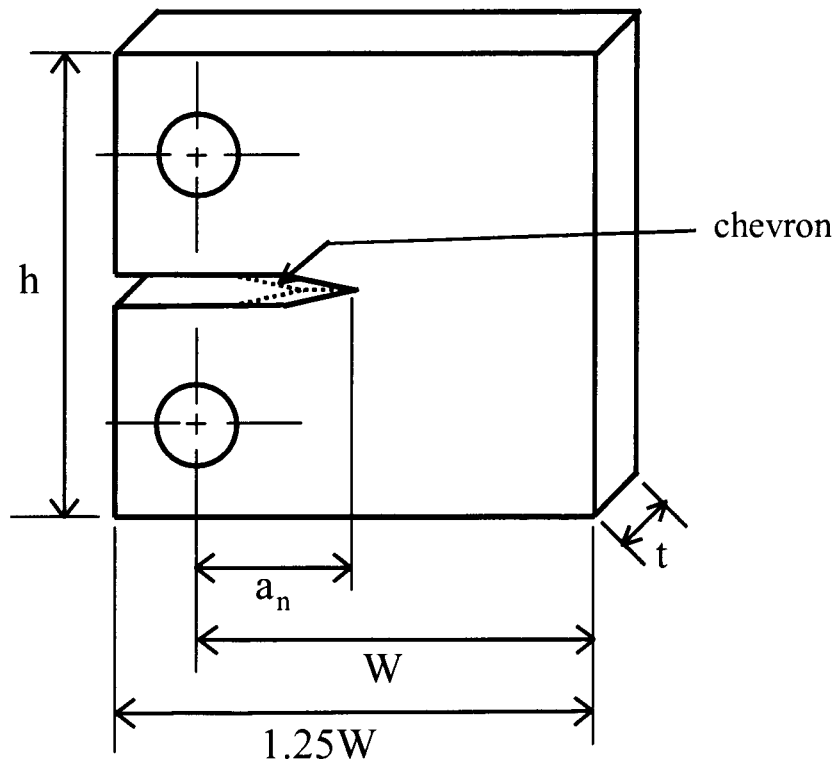
Figure 3. The figure shows the general configuration and dimensions for C(T) and WOL specimens.

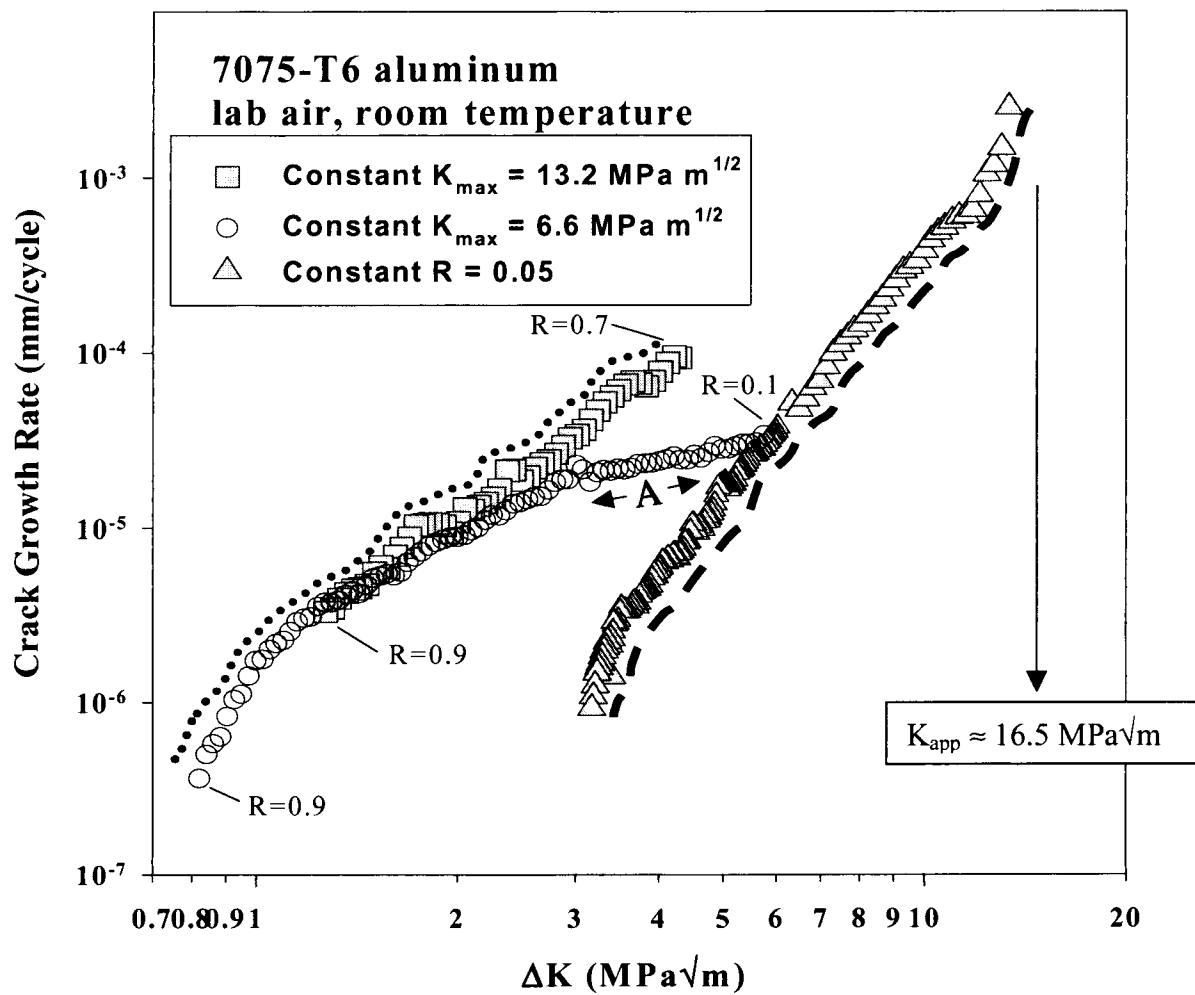
The fatigue crack growth (FCG) characteristics of the C5A forging material exposed to room temperature laboratory air are shown in Figure 21. The plot of  $da/dN$  versus  $\Delta K$  shows the results of three FCG tests conducted using 30.5 mm wide C(T) specimens machined from the tie-box forging arm region shown in Figure 9. The specimen orientation was such that fatigue crack propagation was in the identical direction as the cracking observed in the forging arm region. Three FCG tests were conducted in laboratory air (relative humidity (RH) was not controlled or measured - the laboratory RH could range between 30 and 60%); one constant  $R = 0.05$  test and two constant  $K_{max}$  tests at  $K_{max} = 13.2 \text{ MPa}\sqrt{\text{m}}$  (12.0  $\text{ksi}\sqrt{\text{in}}$ ) and  $K_{max} = 6.6 \text{ MPa}\sqrt{\text{m}}$  (6.0  $\text{ksi}\sqrt{\text{in}}$ ) were performed. During the constant  $K_{max} = 13.2 \text{ MPa}\sqrt{\text{m}}$  test (square symbols), the applied stress ratio was high, ranging from 0.7 to 0.9, and FCG rates ( $da/dN$ ) were not influenced by closure effects. For the  $K_{max} = 6.6 \text{ MPa}\sqrt{\text{m}}$  test (circle symbols), the applied stress ratio varied between  $R = 0.1$  and  $R = 0.9$ ; here, high  $R$  closure-free fatigue crack growth rates were identical to that observed during the high  $R$  constant  $K_{max} = 13.2 \text{ MPa}\sqrt{\text{m}}$  test. Region A shown in Figure 21 identifies the data produced at low stress ratio; here, lower  $R$  fatigue crack growth rates (circle symbols) are reduced compared to the high  $R$  data (square symbols). At the  $R = 0.1$   $da/dN$  converges to closure effected  $da/dN$  produced during the constant  $R = 0.05$  test (triangle symbol). The FCG region designated region A was likely influenced by crack closure resulting in decreased  $da/dN$  compared to the high  $R$  constant  $K_{max}$  FCG results. Respectively, the dotted and dashed lines shown in Figure 21 identify those data that represent the intrinsic (closure-free) and extrinsic (closure-affected) fatigue crack growth characteristics of the C5A 7075 forging. It is important to note that the intrinsic fatigue crack growth characteristics reveal that crack growth continued at extremely low crack-tip stress intensities ( $< 0.8 \text{ MPa}\sqrt{\text{m}}$ ). At constant  $R = 0.05$ , the unstable crack growth rate data reveal an apparent toughness  $K_{app} \approx 16.5 \text{ MPa}\sqrt{\text{m}}$  (15.0  $\text{ksi}\sqrt{\text{in}}$ ).

Figure 21. A plot shows the intrinsic (closure free) and extrinsic (closure affected) fatigue crack growth characteristics of the C5A tie box material.

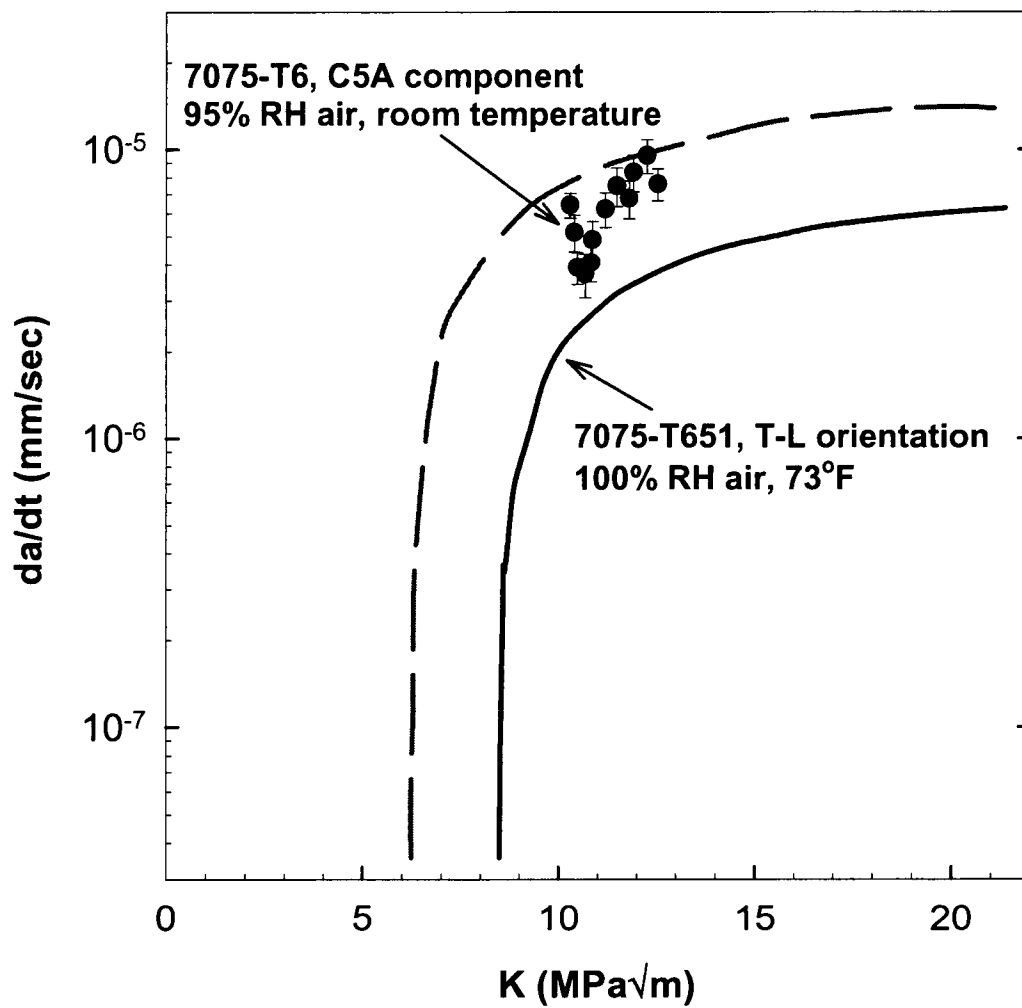
Stress corrosion cracking tests were performed in  $>95\%$  relative humidity air using specimens machined from the C5A component. The data are plotted as  $da/dt$  versus applied stress-intensity factor ( $K$ ) in Figure 23 (solid circular symbols). Here, the applied  $K$  varied between 10 and 14.5  $\text{MPa}\sqrt{\text{m}}$ . Because average crack growth rates are plotted in Figure 23, bars have been placed on each data point to represent the maximum and minimum rates observed during the time interval for which the average crack

growth rate was calculated. For comparison, SCC results for AA7075-T651 exposed to 100% relative humidity air [4] are also shown in Figure 23 (solid line). The comparison reveals that the C5A forging material exhibited accelerated SCC growth rates, by a factor of 2 to 4 as compared to the 7075-T651 plate alloy. The dashed line shown in Figure 23 represents the “upper bound” of the C5A data; here, the dashed curve has been given the same general shape as the 7075 plate SCC results and has been arbitrarily drawn though the upper most forging SCC data. Using the “upper bound” curve, a  $K_{ISCC} = 6 \text{ MPa}\sqrt{\text{m}}$  was estimated for the C5A forging alloy.

Figure 23. The plot shows the stress corrosion cracking characteristics of C5A tie box material in 95% relative humidity air.
